DRAWINGS BY *George Pereira*
APRIL 20, 1983

OSPREY 2 NEWSLETTER
35079 Road J
Oconomowoc, WI 53066

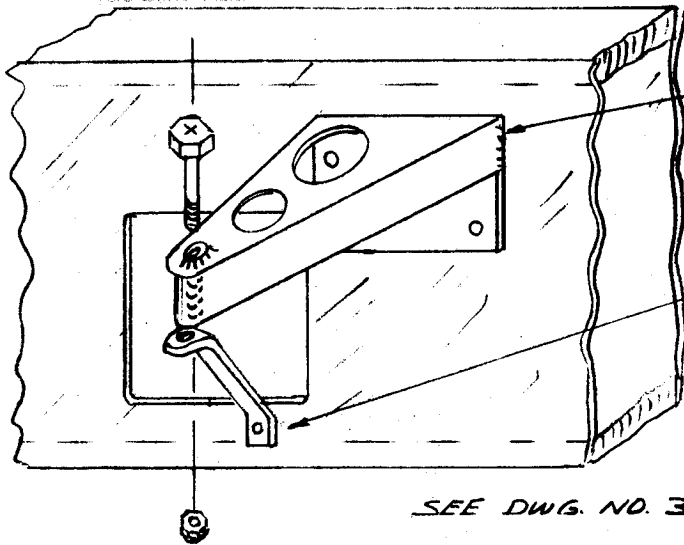
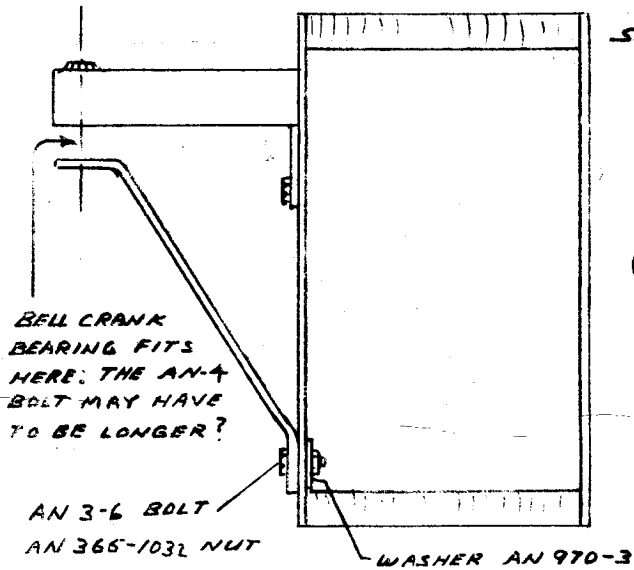
SEE DWG. NO. 33

A couple of builders have mentioned that the aileron bracket shown on drawing No. 33 has a tendency to flex up and down when a heavy aileron load is applied. This could possibly cause the bracket to fail in the welded area if flexing continues. A simple fix to this potential problem is to attach a simple brace from the underside of the bellcrank bearing down to the spar web. (See enclosed drawing) A problem of retrofitting this brace is drilling the 3/16" hole in the web working through the inspection hole. If you don't have a close right angle drill you can sharpen a round 3/16 dia. rod, heat it and burn a neat hole through the web using the brace hold as a guide. I recommend all builders to look into this if your Osprey is finished or install the brace while building this portion of your control assembly. The Derrick built bracket now has a set of bolts top and bottom on the mount flange and will probably negate any need for the brace. Derrick made a change in this bracket about two years ago. If you have his later bracket the mount flange will be different than the drawing. The mounting holes are above and below the welded bracket. If you have the older bracket use the brace.

BRACE PREVENTS
POSSIBLE WELD
FISSURE HERE:

TO DRILL WEB
USE NOT 3/16
DIA. ROD TO BURN
HOLE IF YOU DONT
HAVE CLOSE IN
RT. ANGLE DRILL
MOTOR

AN 3-6 BOLT
AN 365-1032 NUT

WASHER AN 970-3

.125 THK. ALUM. BRACE: LENGTH TO FIT

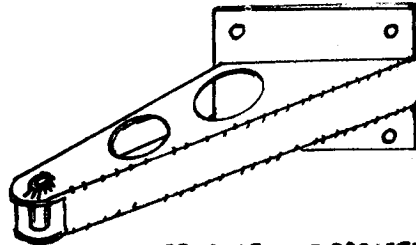
REDESIGNED BRACKET
NOW FURNISHED BY
DERICK
